Legacy Forest Defense Coalition
P.O. Box 7154
Tacoma, WA 98417
Phone: (360) 872-3264
Email: info@wlfdc.org

May 13, 2024

Re: Geomorphic Analysis – Pilchuck River near Bologna Timber Sale Units 1 and 2

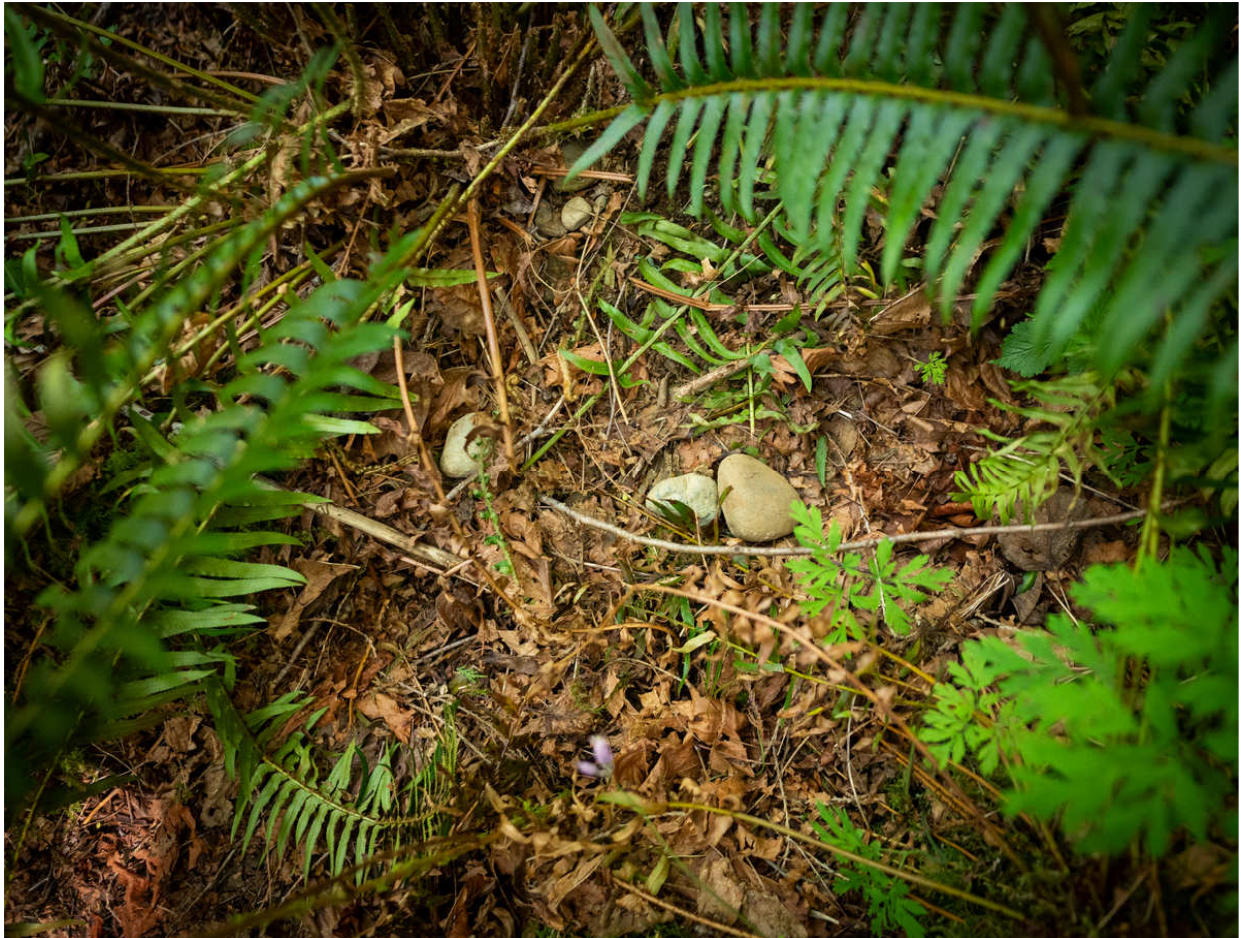
The Forest Practices Board Manual defines four components of the CMZ: (1) the historic channel migration zone (HMZ), (2) the avulsion hazard zone (EHA), (3) the erosion hazard area (HA), and (4) the disconnected migration area (DMA). Unit 1 of the Bologna timber sale is adjacent to an alluvial terrace that is within both the EHA and the HMZ (Figure 5). We found river gravel right along the northwestern boundary of Unit 1, which is clear indicator that water has been flowing through this area in the recent past (Figure 1).

Figure 1. River Gravel Found Along Northwest Edge of Unit 1

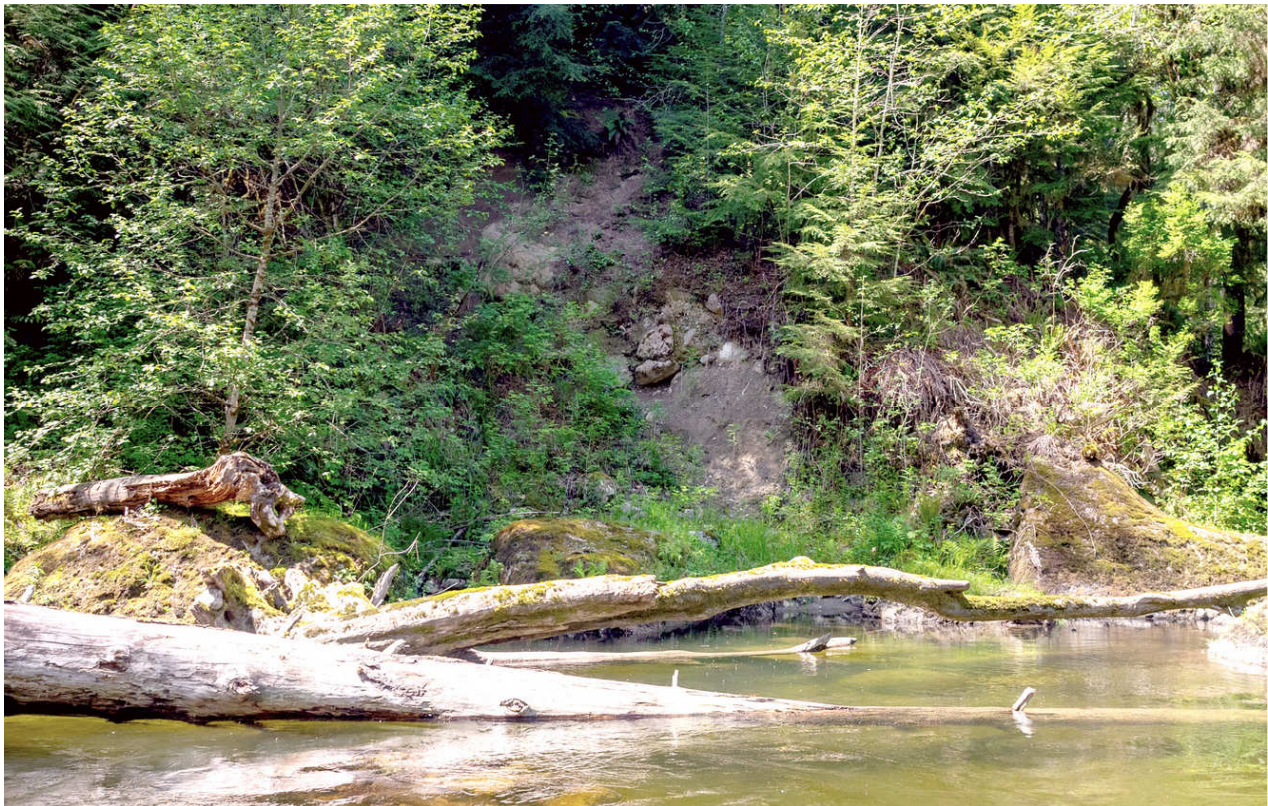
Figure 2. Bank Failure on Outside of Meander Bend
(River is cutting a new channel behind the small tree in the foreground.)

Dudley and Click's statement that there has been no measurable retreat of the river bank north of Unit 2 within the past 67 years is contradicted by their own analysis. Figure 5 of their memorandum, which is based on historic aerial photos, reveals that the river bank has retreated by about 200 feet, and river is still actively eroding the glacial outwash terrace at this location. A large portion of the terrace has recently collapsed, as is obvious in Figure 2 (above). The river has cut its way around the boulder in the foreground and formed a new channel that runs along the toe of the terrace. This is a pattern that repeats itself: the river undermines the terrace until the slope can no longer support its own weight. The bank collapses, and the river moves further inland.

Similarly, the sharp meander bend in the river just north of Unit 2 is actively migrating outward and eroding away the terrace on which Unit 2 is located. The 100-foot buffer that DNR has established is clearly inadequate, and almost certainly violates state law, which again requires a minimum 90 to 200 foot buffer, extending outward from the edge of the EHA.

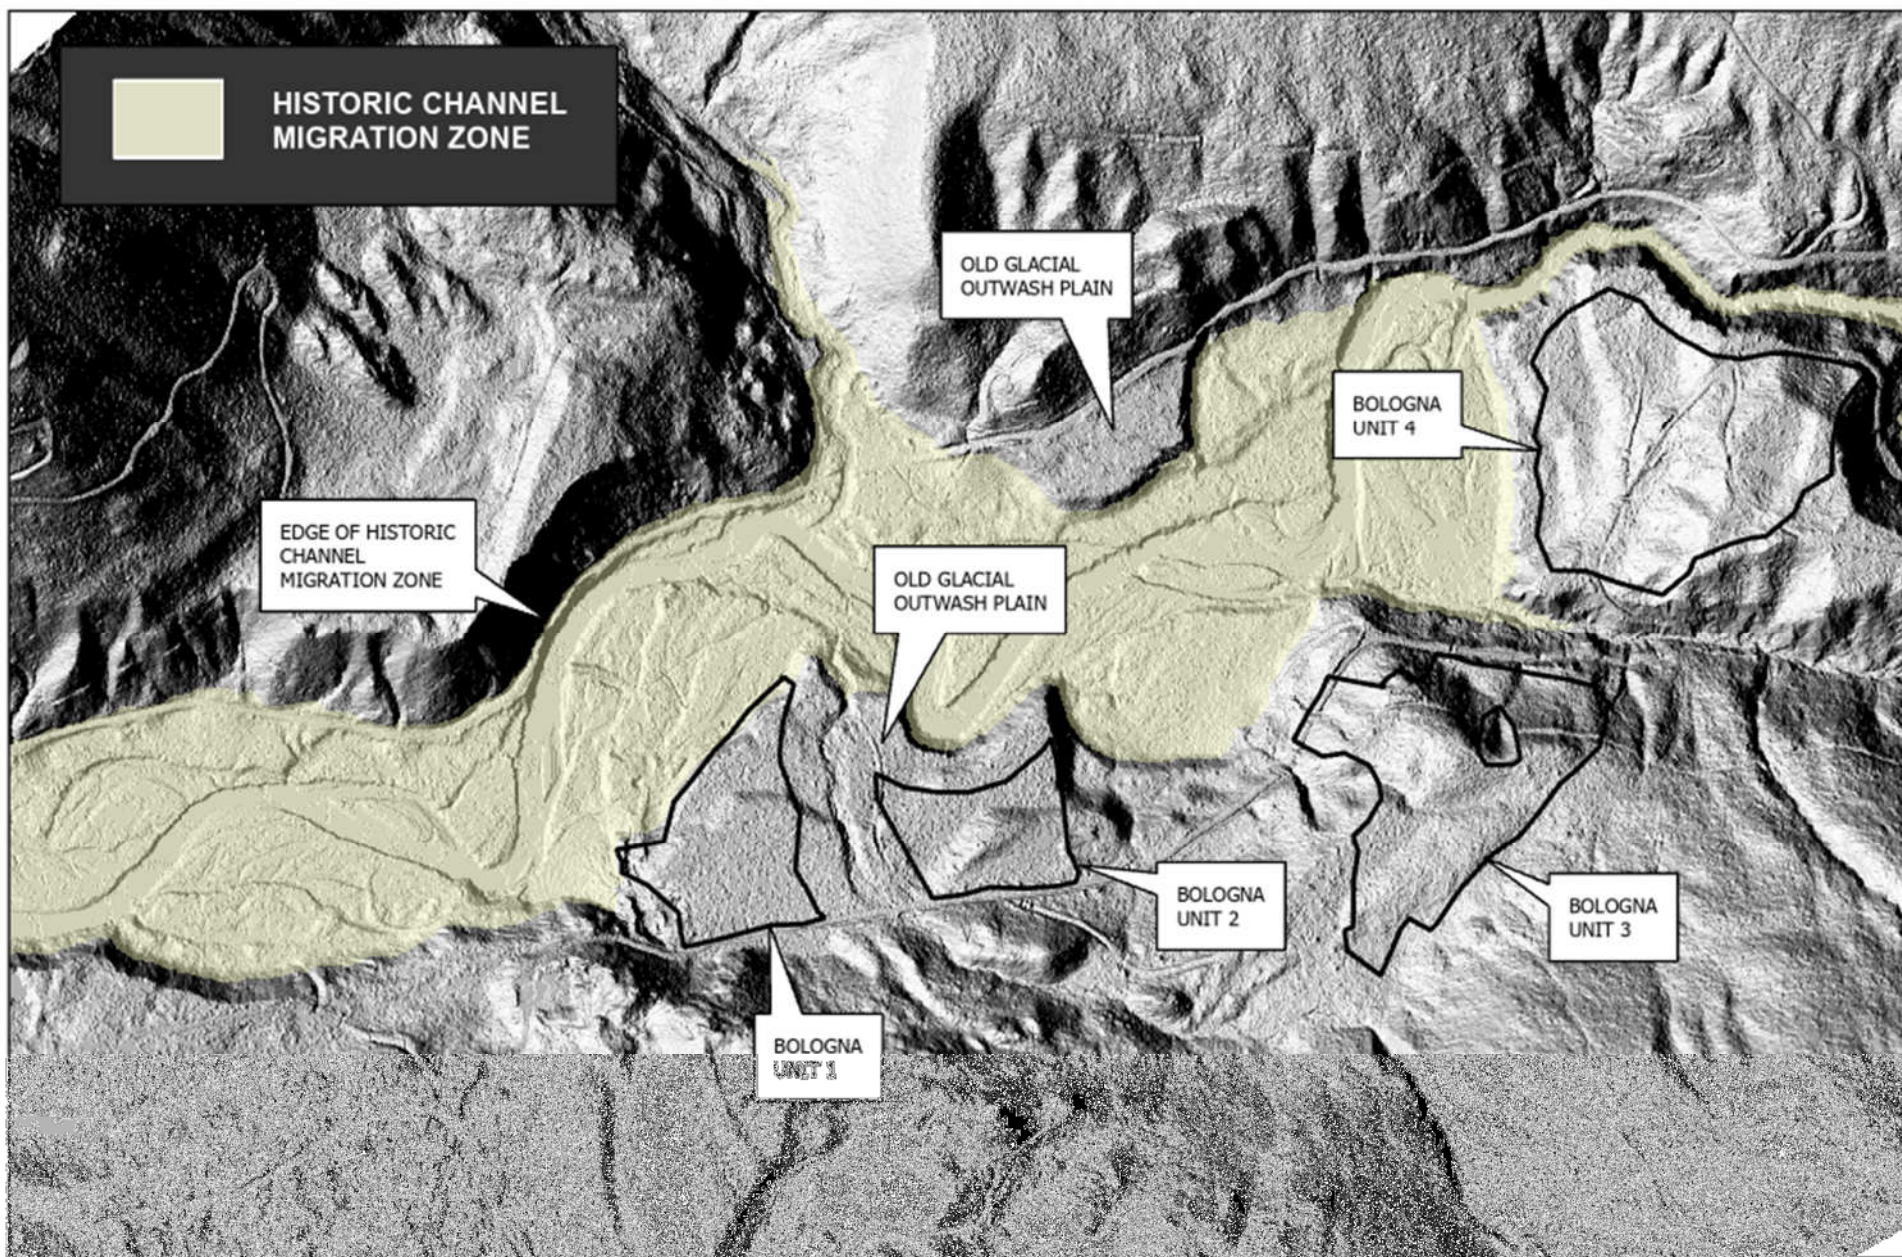
Figure 6. Historic Channel Migration Zone

Units 1 and 2 of the proposed “Bologna” timber sale are located directly on top of one of the few remaining glacial outwash terraces in the Pilchuck River valley (Figure 6). The northwest edge of Unit 1 of the Bologna timber sale runs right along the outer boundary of the active channel migration zone, while the river is actively eating into this terrace near the north end of Unit 2 of the timber sale. There is no doubt that the river will continue to erode this terrace. Logging the terrace will further destabilize the already erodible glacial deposits, and increase the rate of bank erosion and future channel migration, by eliminating a future source of large wood recruitment.

Dudley and Click mischaracterize the HMZ as limited only to those channel boundaries that can be seen in available aerial photos. In reality, the HMZ extends all the way to the northwest edge of Unit 1 of the Bologna timber sale (Figure 6).
